Updating the PIR-1 Firmware

Last Modified on 08/09/2023 6:24 pm EDT

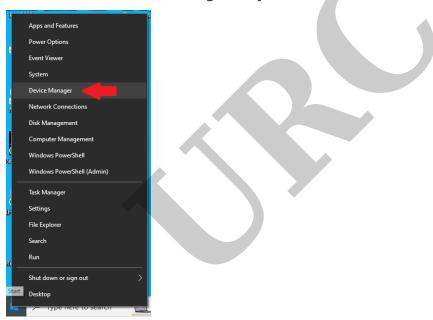
Symptom: When connecting a PIR-1 to URC Accelerator or Complete Control Program software, it requires a Firmware Update, however, when the steps are followed, the update fails every time.

Reason: The chipset within the PIR-1 needs to be updated to work with the latest version of URC software.

- 4. UnZip downloaded file to a designated location/folder
- 5. Go to Windows Device Manager on your PC

- a. Select the COM Port (Ports) section
- b. Right-click on USB Serial Port
