Accelerator 2 Startup Message-Live Update Error

Last Modified on 04/05/2023 2:00 pm EDT

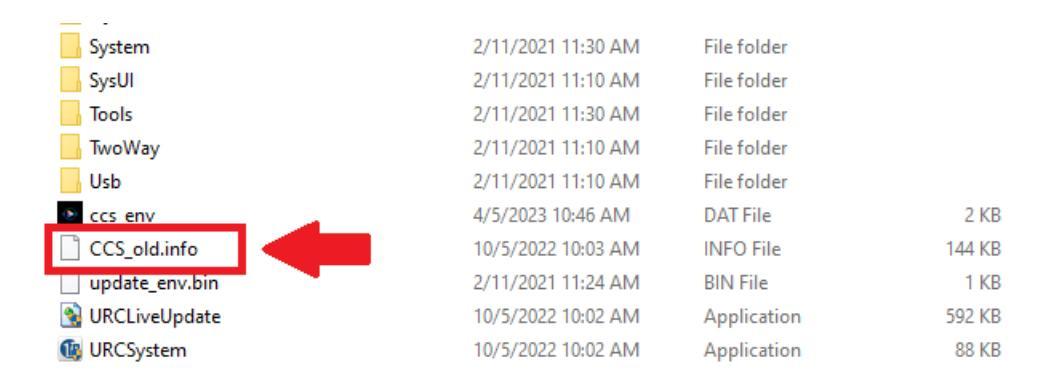
Step #3: Locate the "CCS.info" file shown in the picture below and rename the file to something else like "CCS_old.info".

Note: You may need computer administrator privileges to make this change

Step #4: Restart the Accelerator 2 program to verify that the error is resolved.
