Updating the PIR-1 Firmware

The following article details the process to **update the firmware** of the **PIR-1** Professional IR learner.

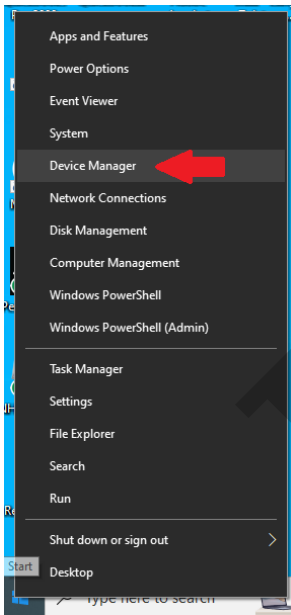
5. Go to **Windows Device Manager on your PC**

a. Select the **COM Port (Ports)** section

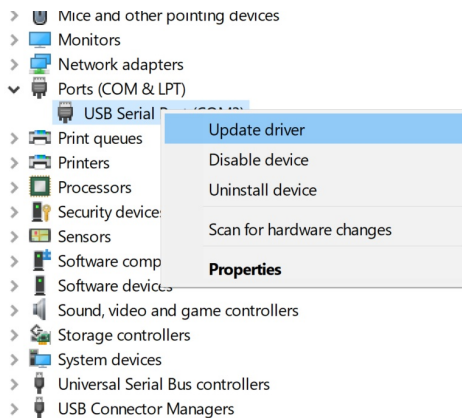
b. Right-click on **USB Serial Port**

c. Select **Update Driver** for USB Serial Adaptor
